ARMY MEDICAL INTELLIGENCE AND INFORMATION AGENCY WAS--ETC F/6 6/12
TESTING OF VACUUM MATTRESSES (ERPROBUNG VON VAKUUM-MATRÄZEN), (U)

TESTING OF VACUUM MATTRESSES

21 Trans. of report from
Academy for Medical Service and Sanitation of
Bundeswehr + (West Germany) 39p.

Testing of Vacuum Mattresses for the BWB Questionnaire

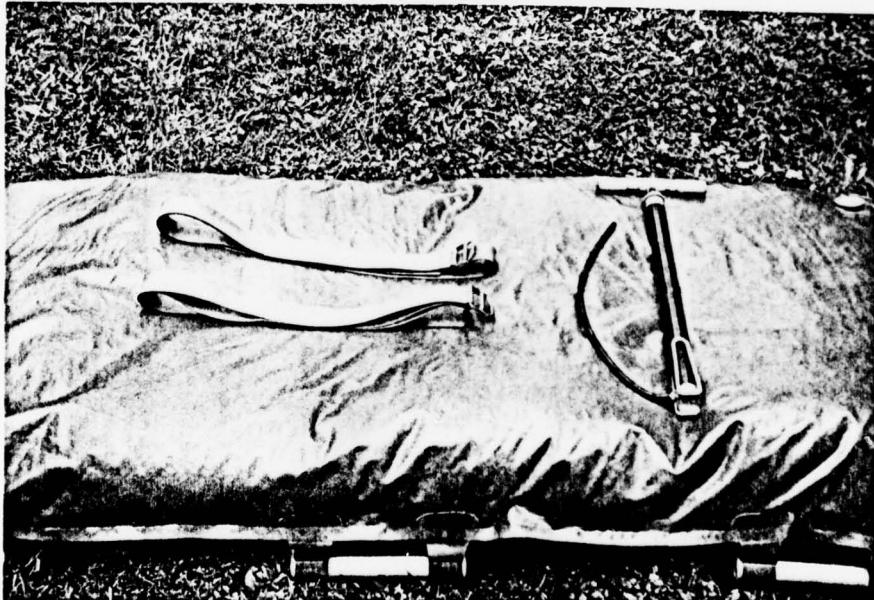
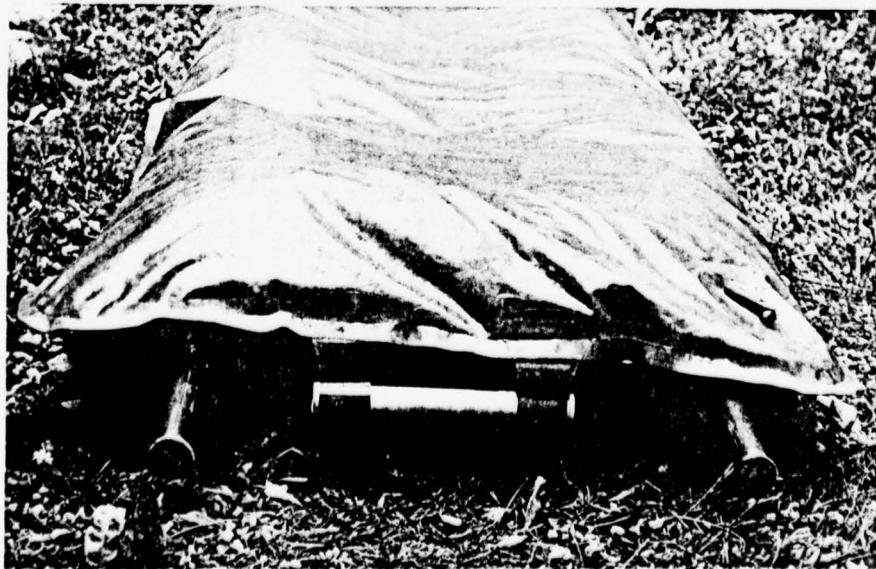
Model 1 - Draeger rescue mattress with handpump and straps

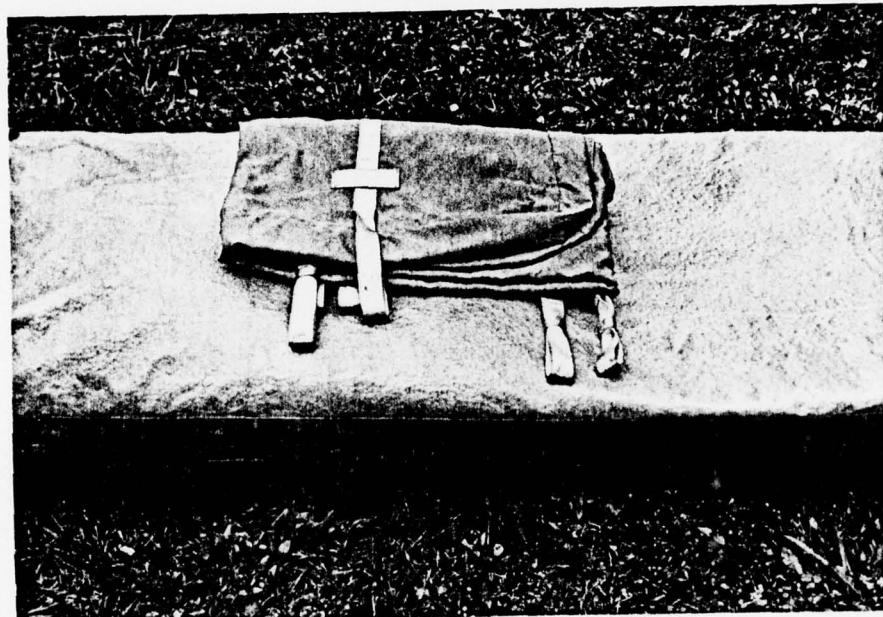
2/1

Laerdal mattress

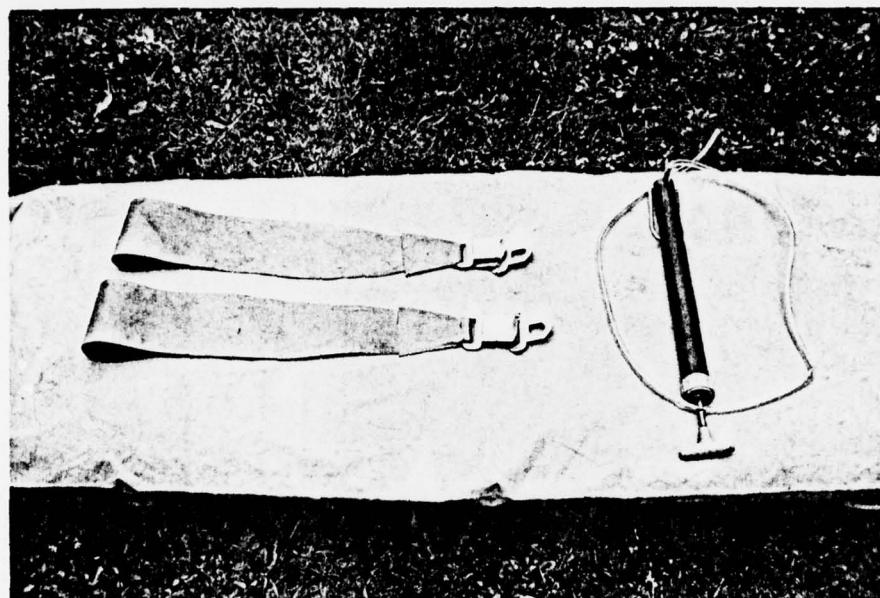
3/1

Original Firn mattress with handpump and straps

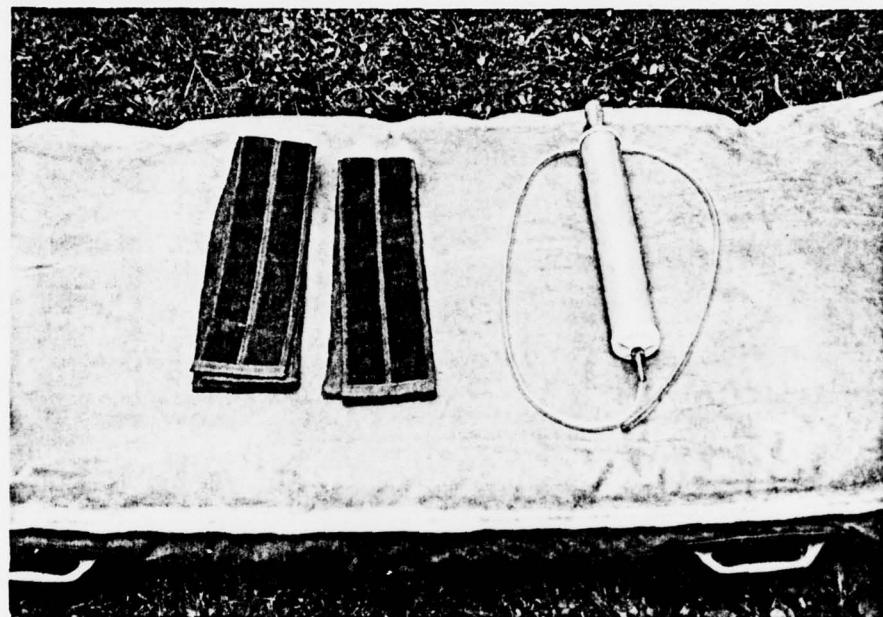
4/1

Soehngen vacuum mattress with handpump, straps and repair pack

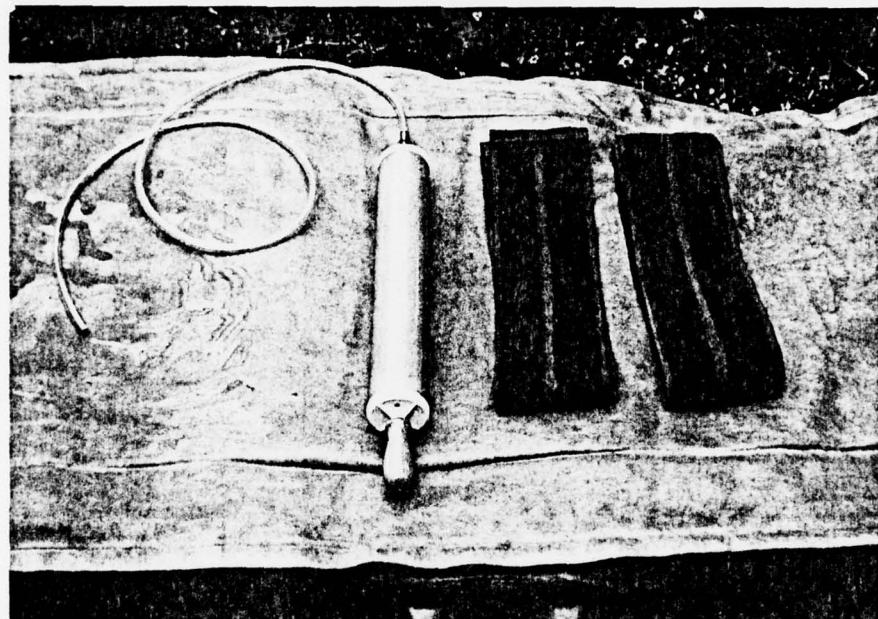
5/1

Soehngen vacuum mattress with three rips on the longitudinal sides. Handpump, straps, repair pack (not Navy service component).
